Brownstone & Masonry Repairs and Exterior Historic Structures Report

Concord Town House

22 Monument Square, Concord, MA 01742

November 8, 2012

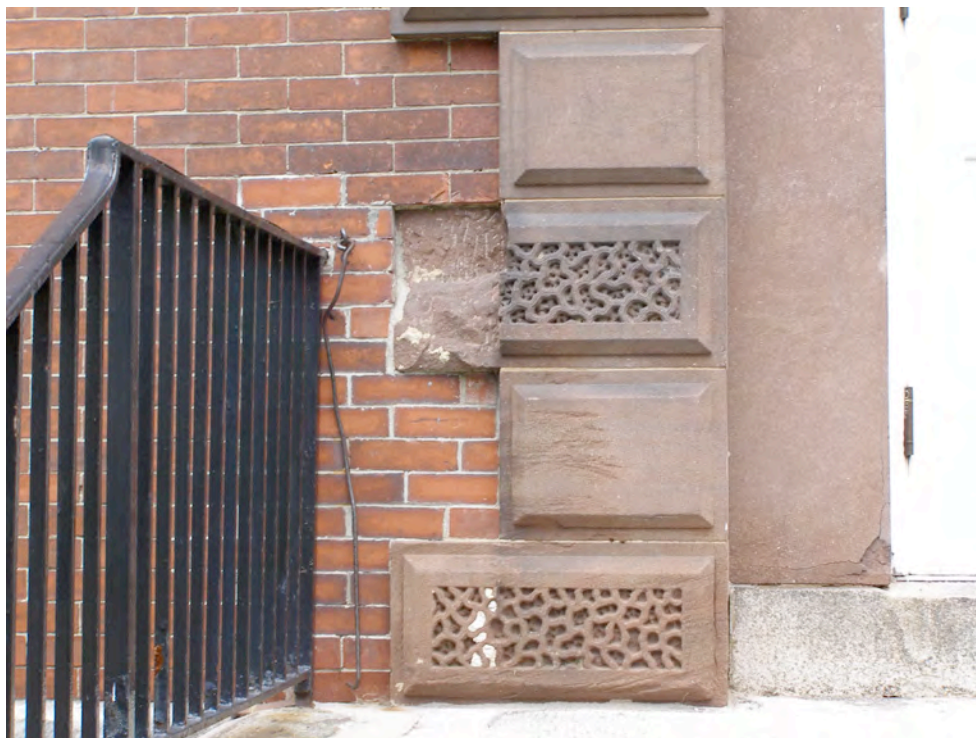
Lower Vermiculated Quoin in 2006

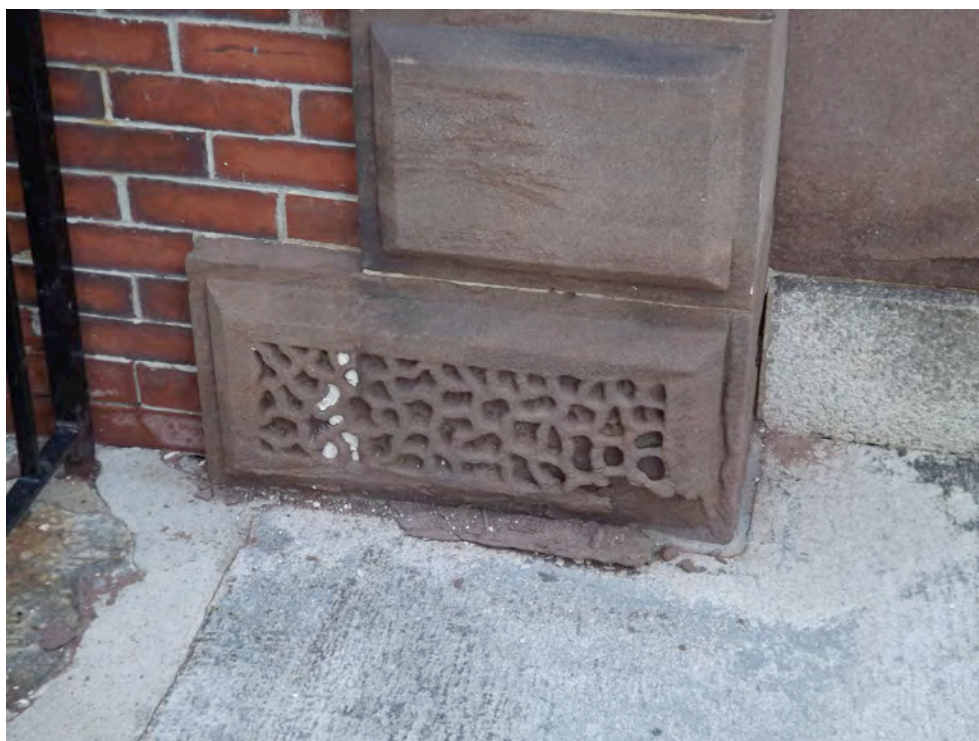
Progression of Deterioration from 2006 – 2012=

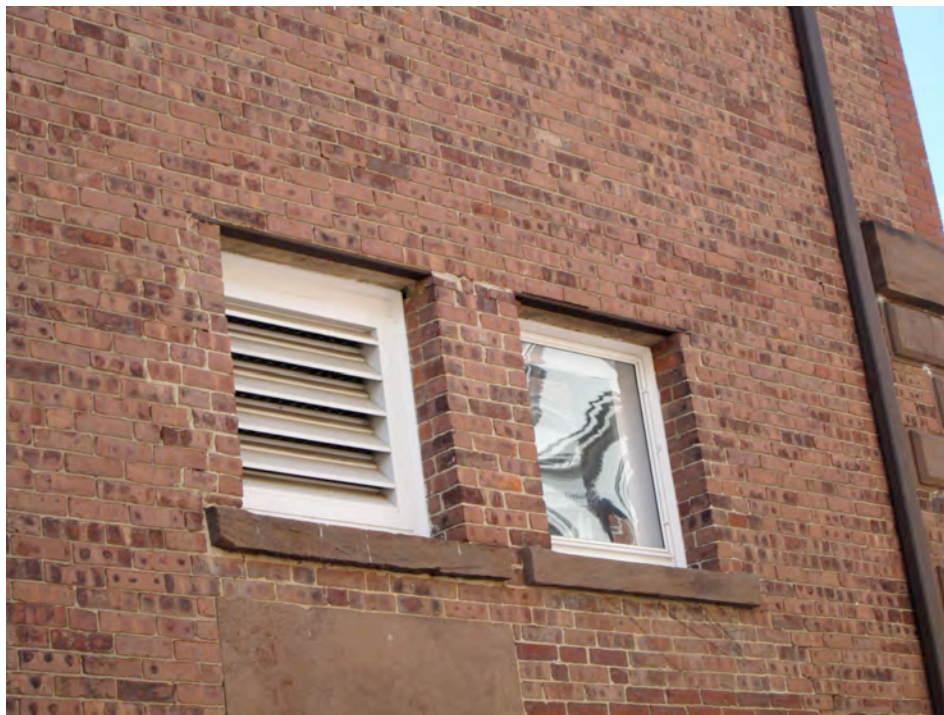
Corrosion at Steel Lintels on the East Elevation

4. Removal of bricks at north elevation to access corroding steel lintels followed by repair of lintels and replacement of bricks.
5. Grouting of cracks in granite units at the foundation.

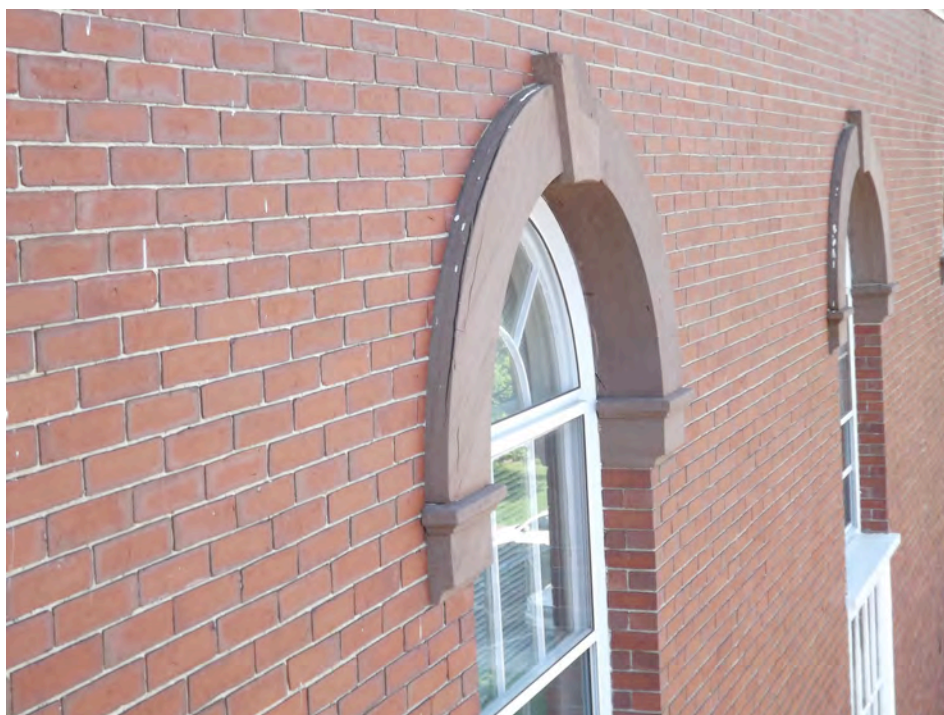
Edge View of Delamination at Facebedded Brownstone Arch Window Surrounds

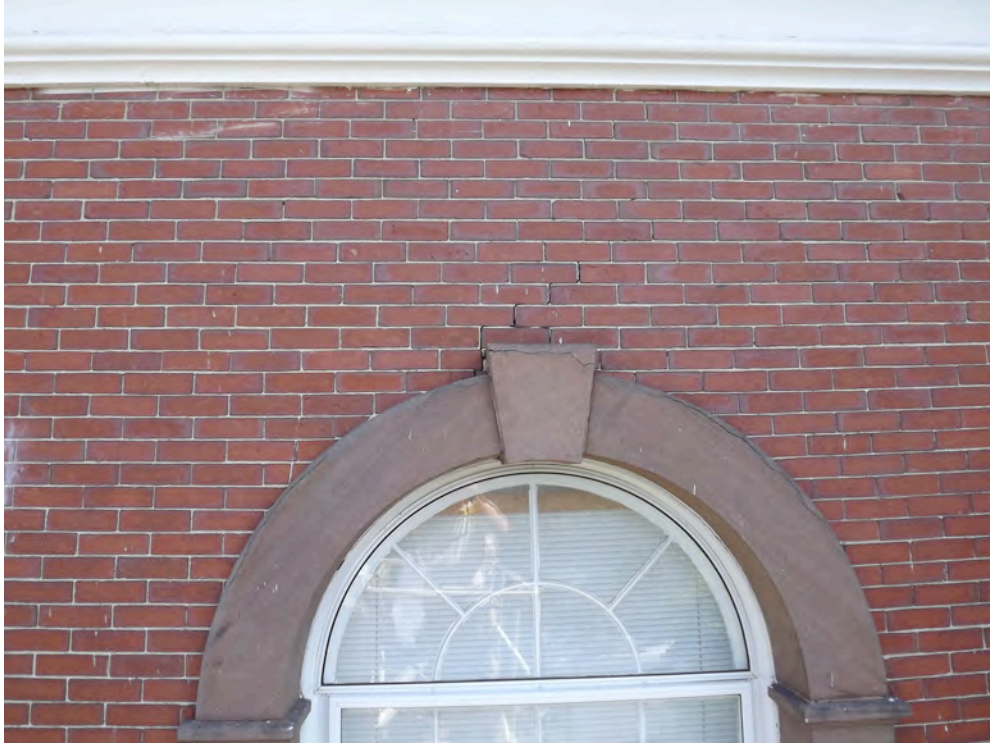
**Frontal View of Cracked and Delaminated Embedded Brownstone Window Surround.
Note Step Crack in Brickwork Above Brownstone Keystone.**

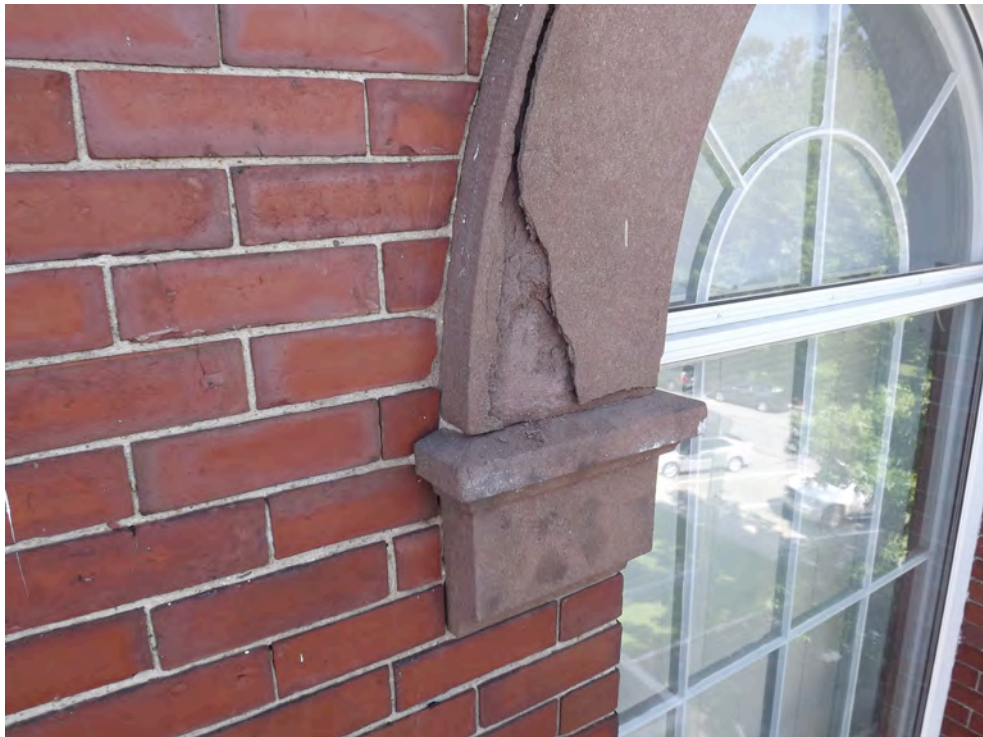
Frontal View of Delaminated Facebedded Brownstone Window Surround

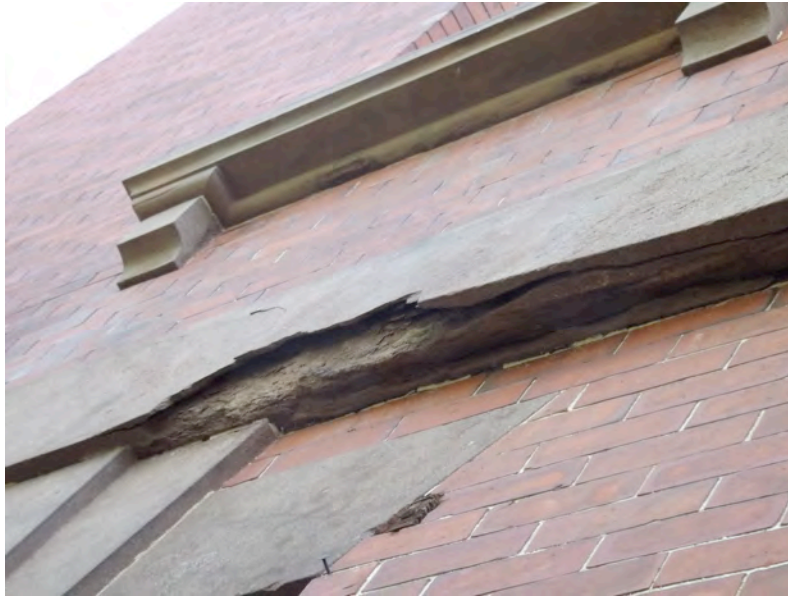
Edge view of delaminated facebedded bandcourse unit.

7. Removal of deteriorated brownstone units at flat band course on south, east and west elevation and replacement with new facebedded brownstone units that are protected on the top with flashing. Alternate treatment would be to replace these units with cast stone.

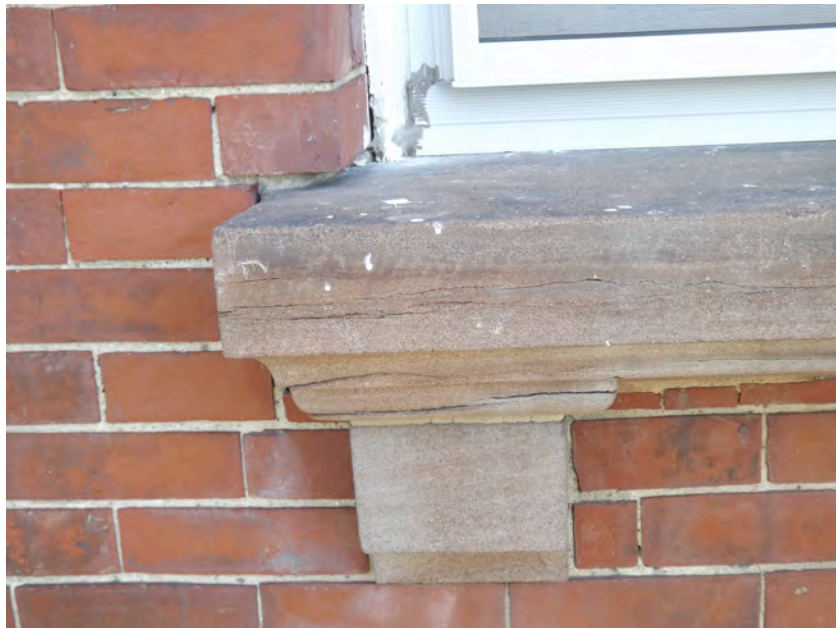
Parallel cracks in naturally bedded window sill

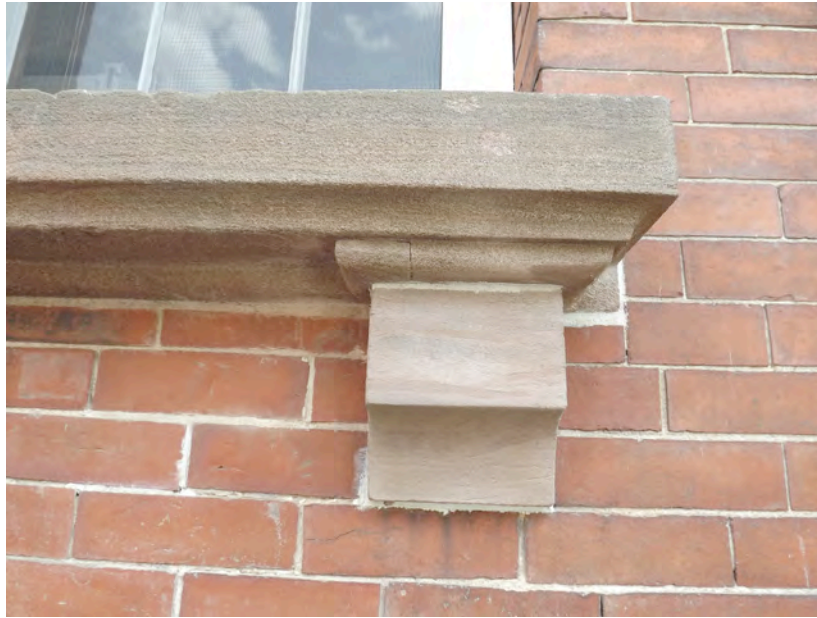
Original brownstone dutchman repair on lower sill directly above bracket.
Note grout repairs at cracked bracket completed since 2006

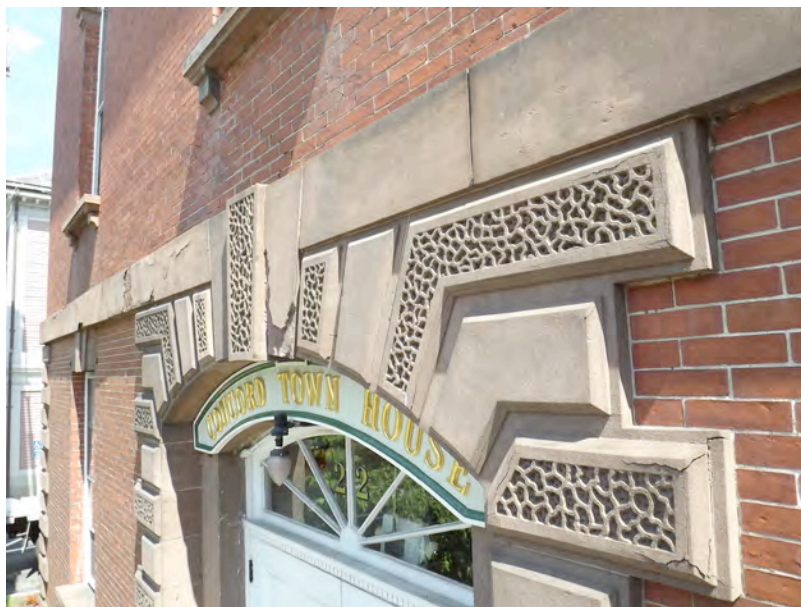
Vermiculated quoins, flat quoins and band above entrance door.
Note cracking at vermiculated quoins.

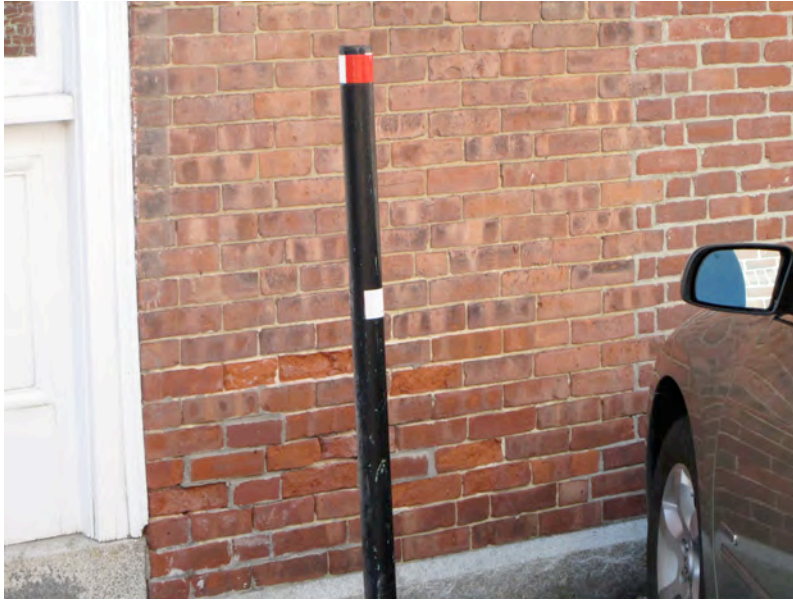
Bricks damaged from rising damp and or snow pushed against the side of the building.

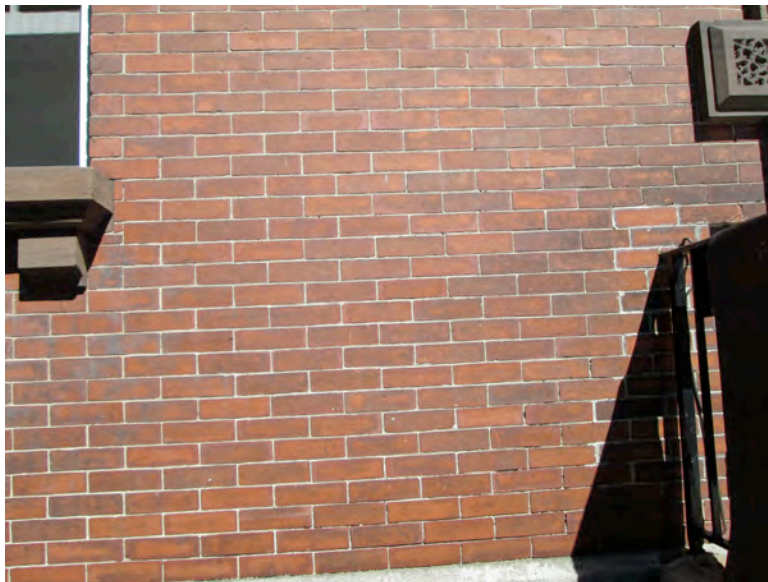
Open and recessed brick mortar joints on west elevation.

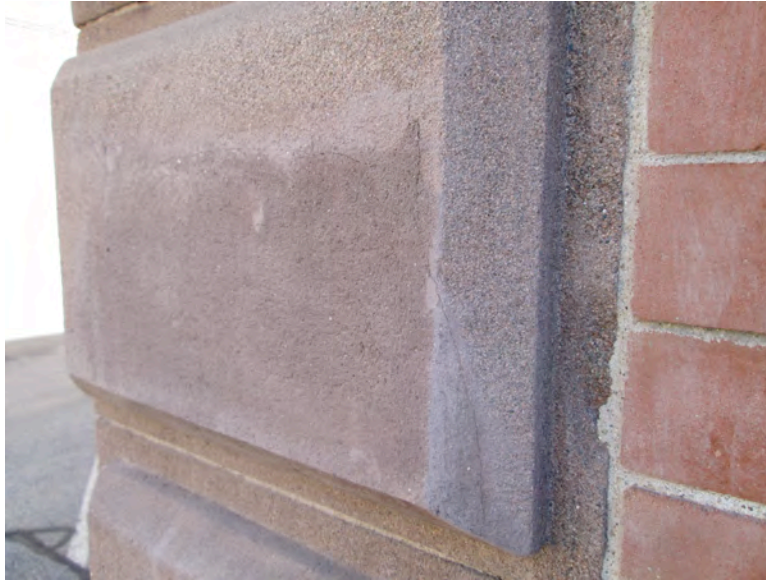
Recently applied patch beginning to crack and separate at the margins

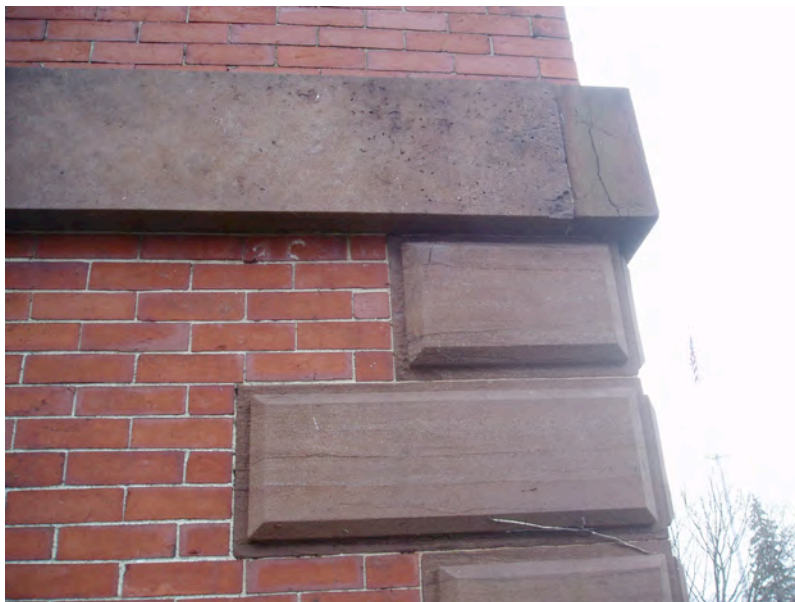
Parallel cracks at naturally bedded quoins.
Note delamination at the return on the bandcourse unit.
